# Bull Creek Watershed

## Visual Assessment Survey

Prepared for:  
Missouri Department of Conservation

Authors:  
Brandy M. Henderson  
and  
Susan A. Sleeth  
Undergraduates  
Missouri State University  
Geology Department

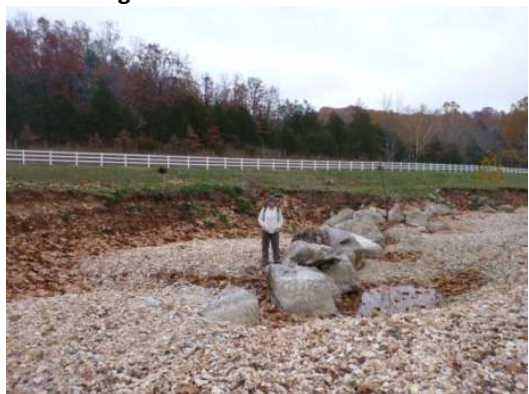
**WFN2.1 Agricultural Influences/Inadequate Riparian Corridor**

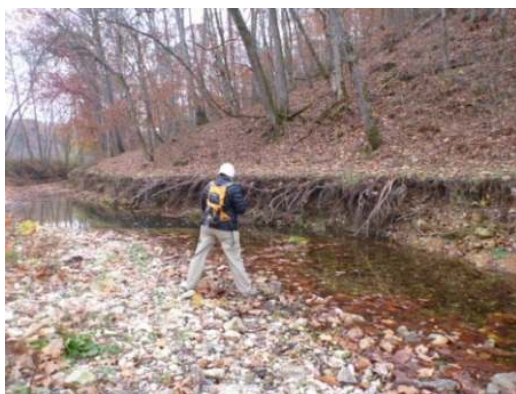
**WFN3 Bank Erosion**

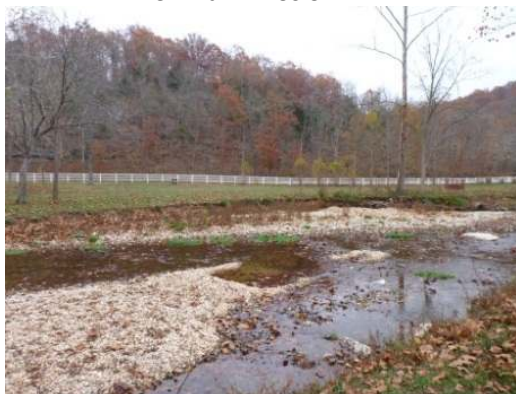
**WFN5 Agricultural Influences/Inadequate Riparian Corridor**

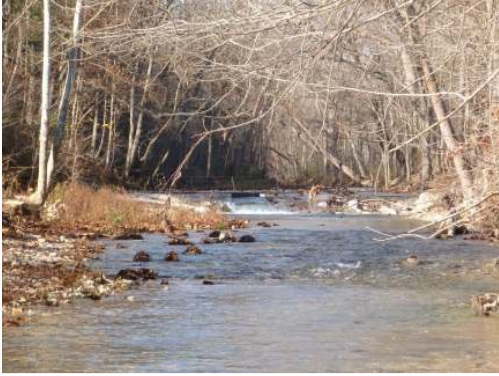
**MWF1 Low Water Bridge**

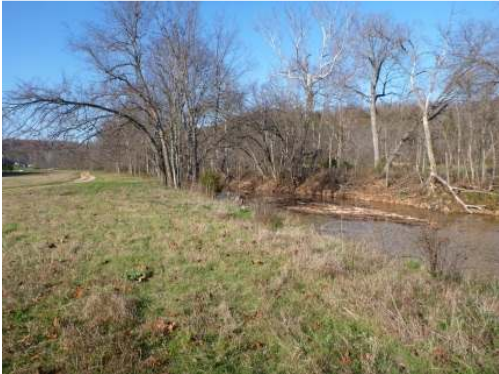
**MWF3 Inadequate Riparian Corridor**

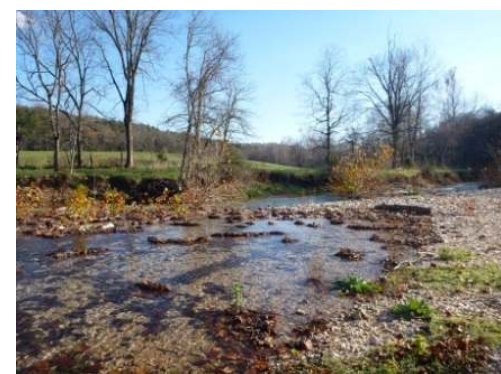
**MWF4 Inadequate Riparian Corridor**

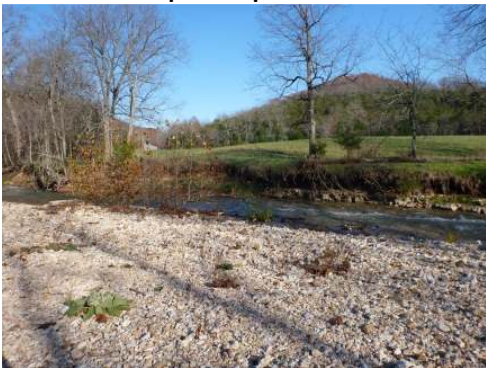
**MWF5 Inadequate Riparian Corridor**

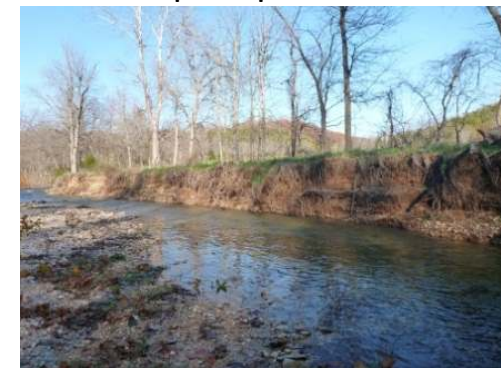
**MWF6 Inadequate Riparian Corridor**

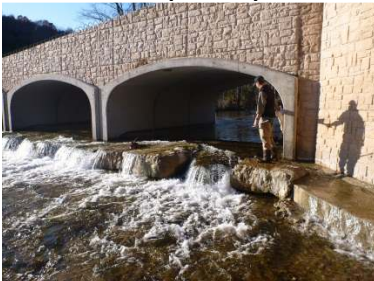
**Bridge-Fish Barrier**

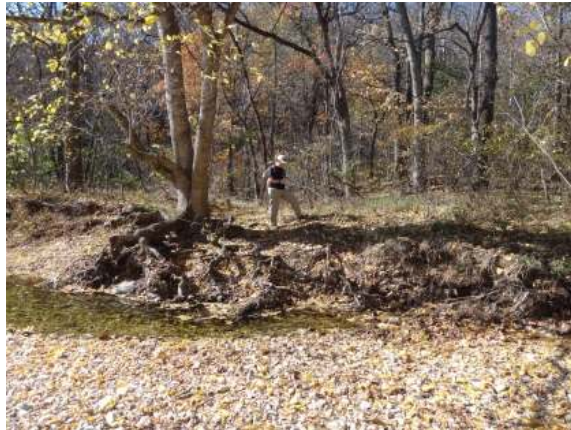
**SWF1 Bank Erosion**

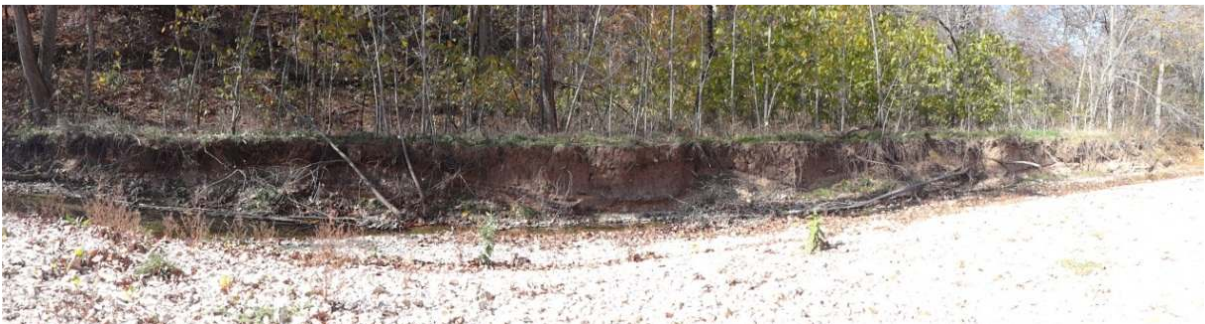
**SWF2 Bank Erosion**

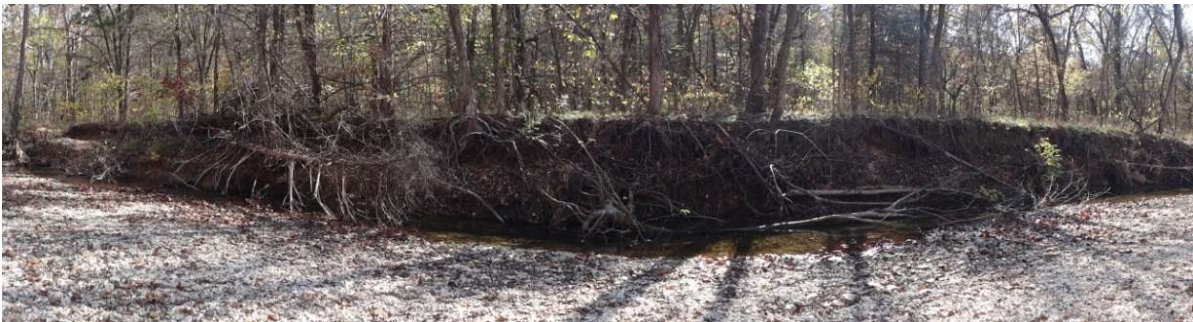
**SWF3 Bank Erosion**

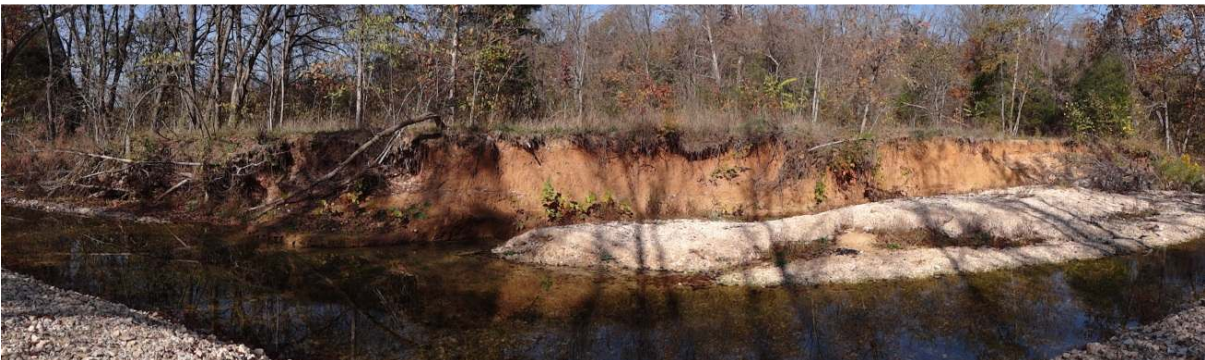
**SWF4 Bank Erosion**

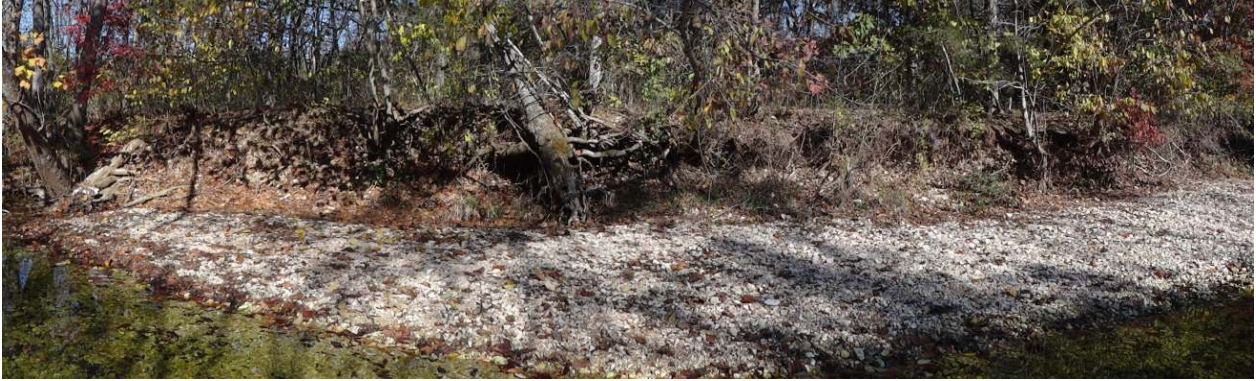
**SWF5 Bank Erosion**

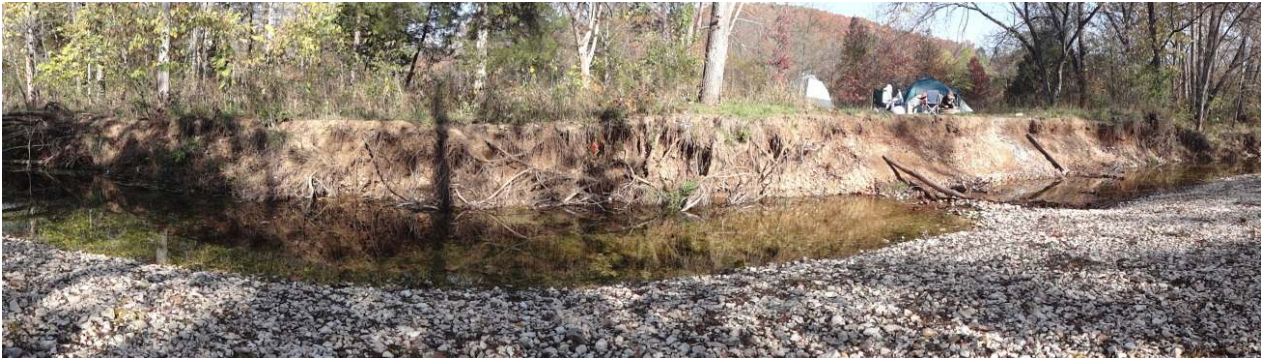
**SWF6 Bank Erosion-Busiek Campsite**

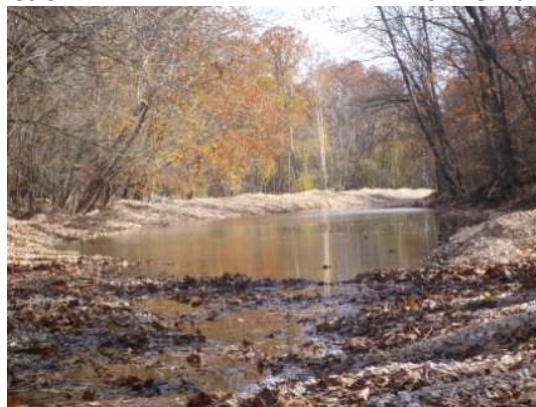
**SWF9 Gravel Accumulation**

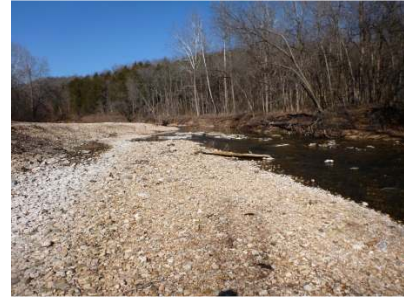
**BCW3 Inadequate Riparian  
Corridor/Bank Erosion**

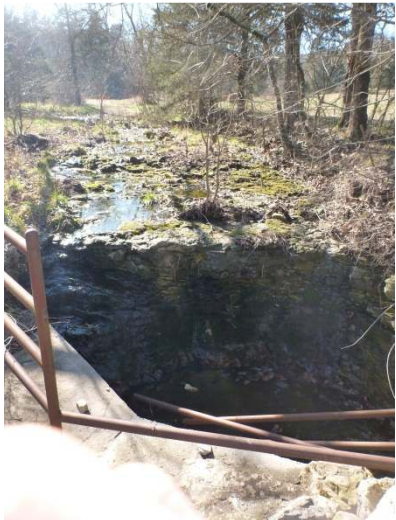
**BCW4 Bridge/Road Crossing**

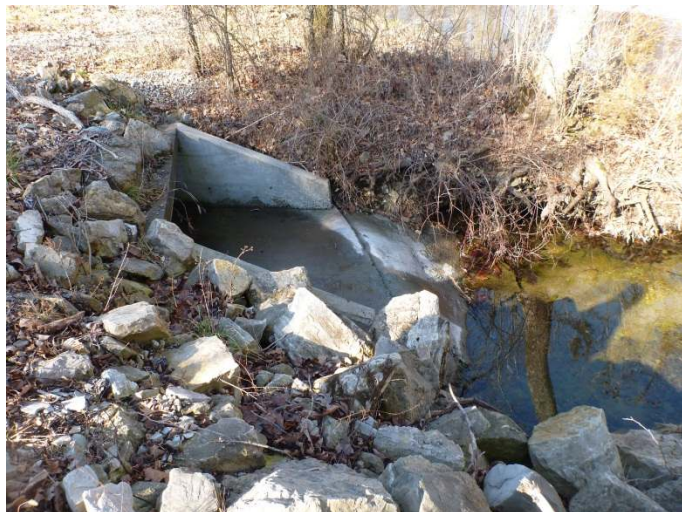
**BCW5 Culvert-discharge**

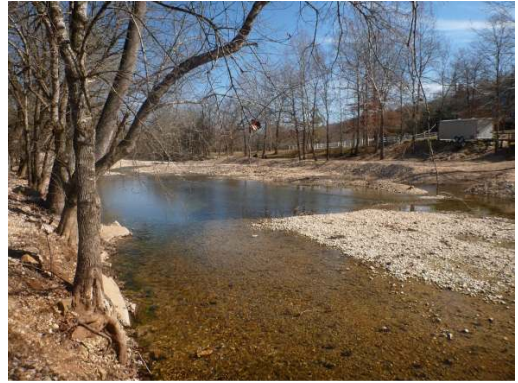
**BCW9 Inadequate Riparian Corridor**

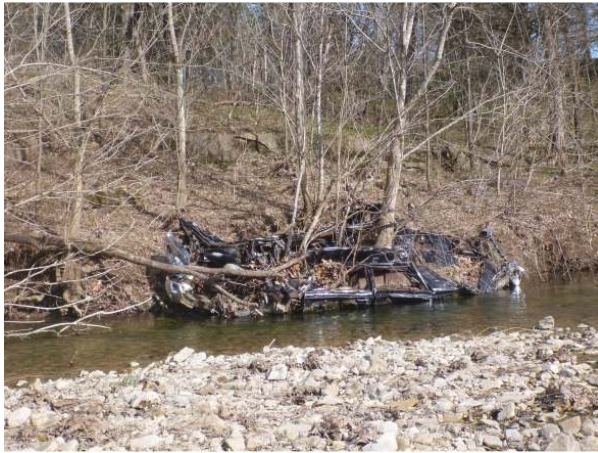
**BCW10 Trash Site**

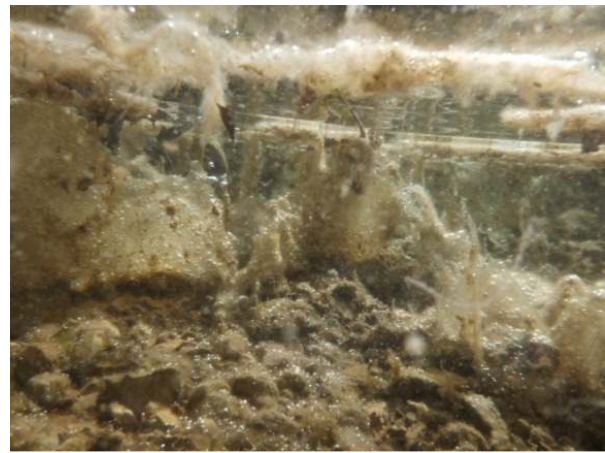
**BCW11 Algae**

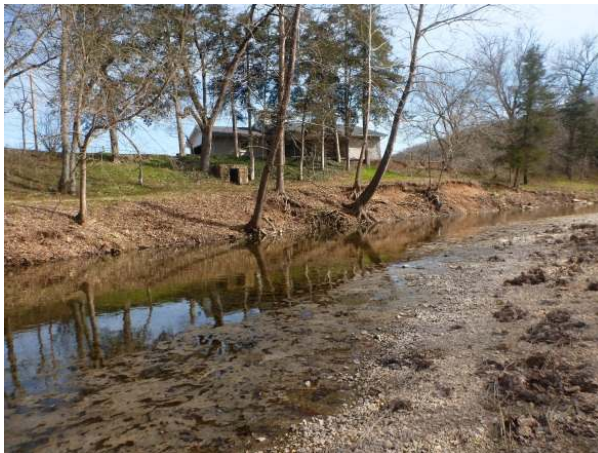
**BCW12 Inadequate Riparian Corridor**

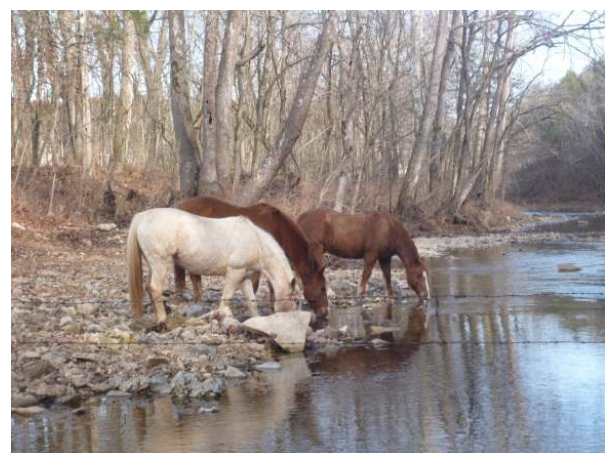
**BCW13 Agricultural Influences-Horse Stream Access**

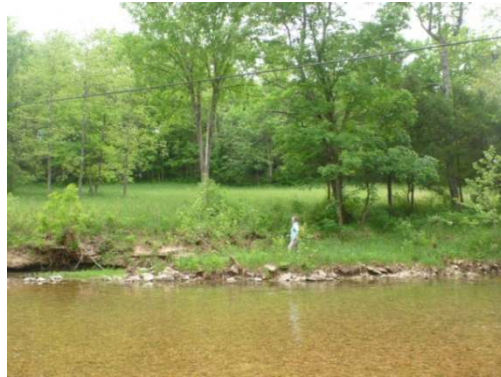
**BCE2 Inadequate Riparian Corridor**

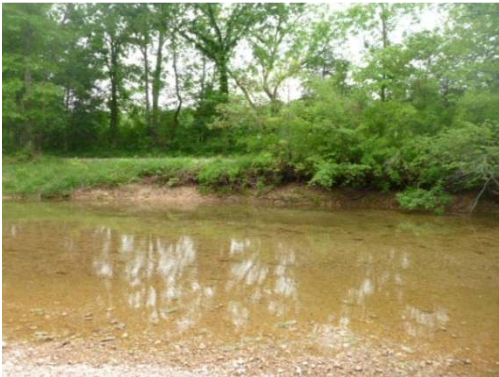
**BCE3 Bank Erosion/ Inadequate Riparian Corridor**

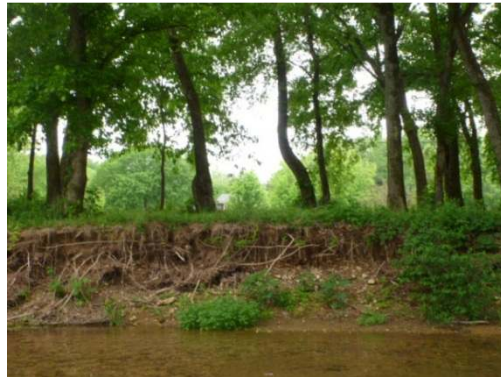
**BCE4 Bank Erosion/ Inadequate Riparian Corridor**

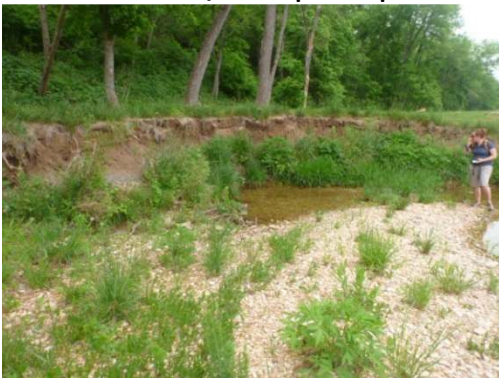
**BCE5 Bank Erosion/ Inadequate Riparian Corridor**

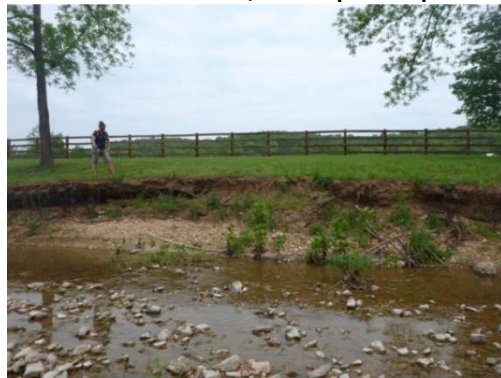
**BCE6 Bank Erosion/ Inadequate Riparian Corridor**

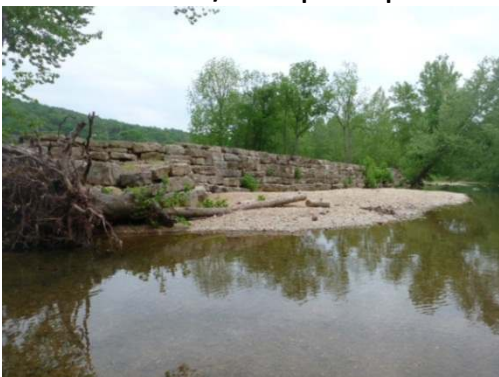
**BCE7 Bank Erosion/ Inadequate Riparian Corridor**

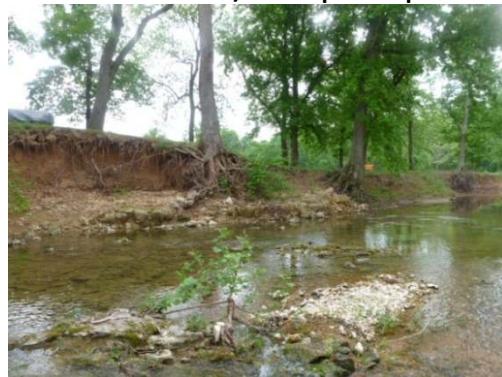
**BCE8 Bank Erosion/ Inadequate Riparian Corridor**

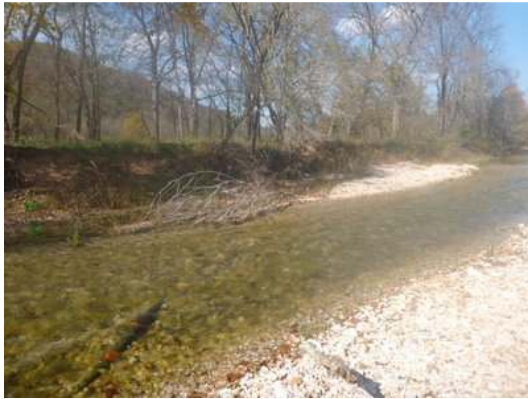
**BCN1 Bank Erosion/ Inadequate Riparian Corridor**

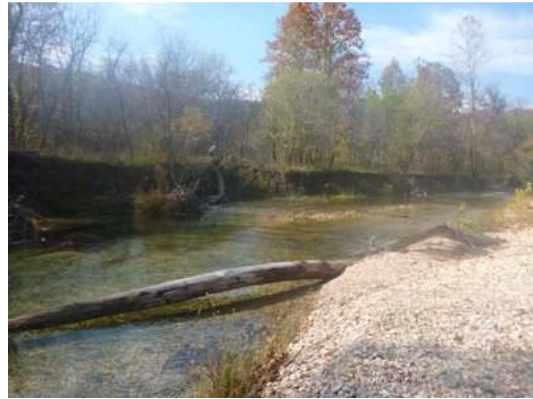
**BCN2 Bank Erosion/ Inadequate Riparian Corridor**

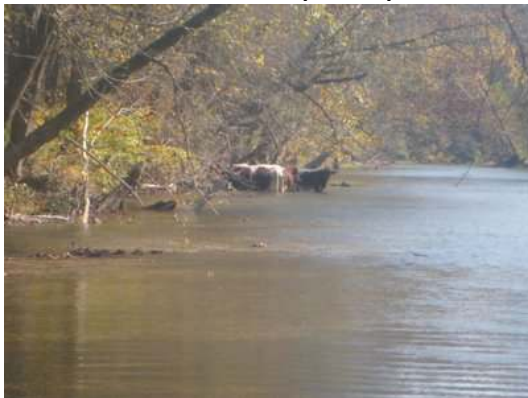
**BCN3 Agricultural Influences-Cattle Stream Access**

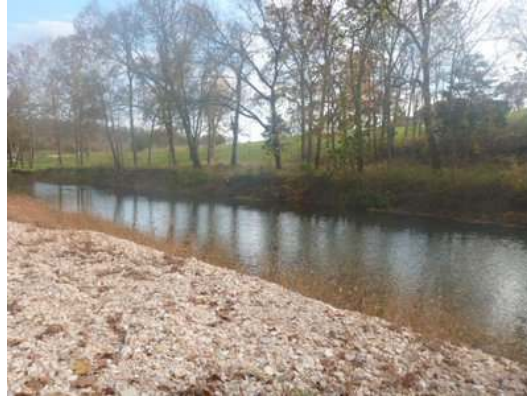
**BCN8 Inadequate Riparian Corridor**

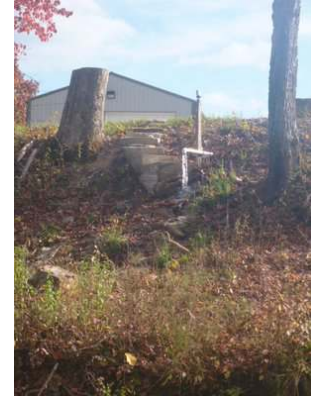
**BCN9 Pipe Discharge**

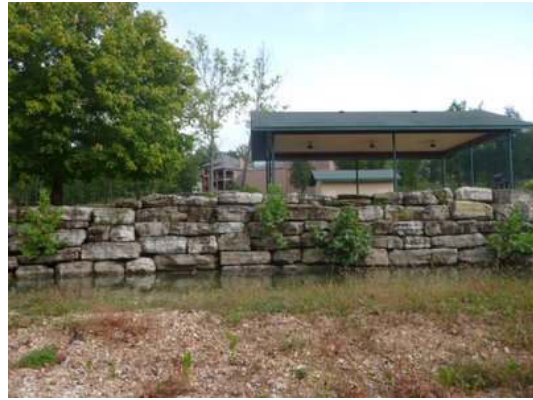
**BCM2 Suburban Influences**

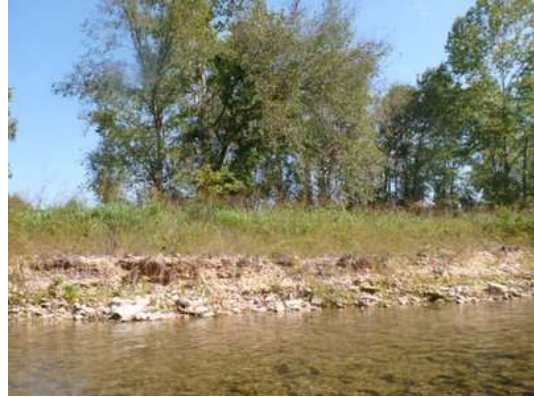
**BCMN8 Inadequate Riparian Corridor**

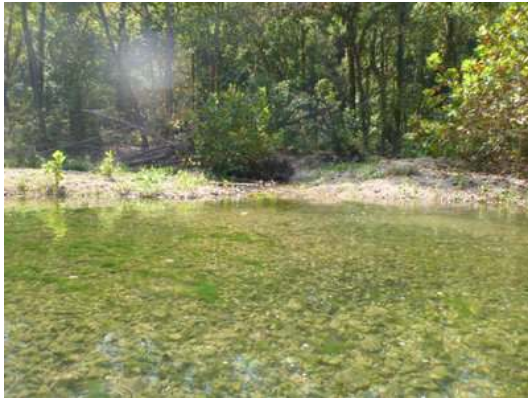
**BCMN9 Aglae**

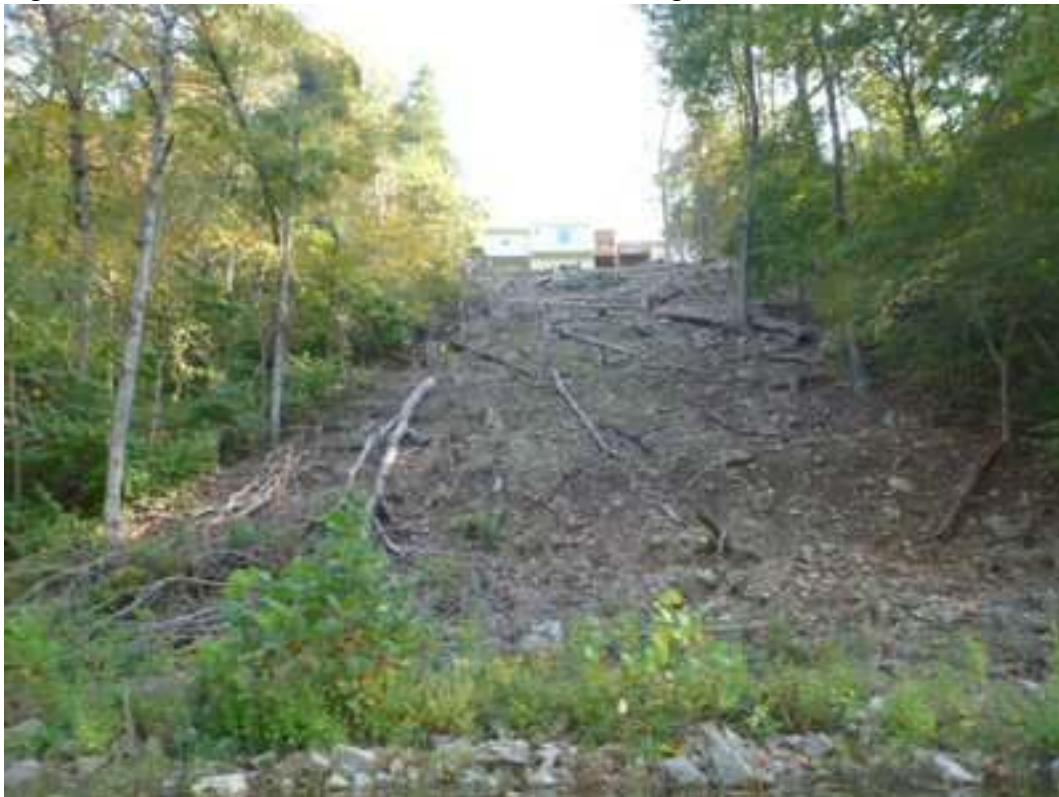
**BCMS3** Clear Cut for Viewshed

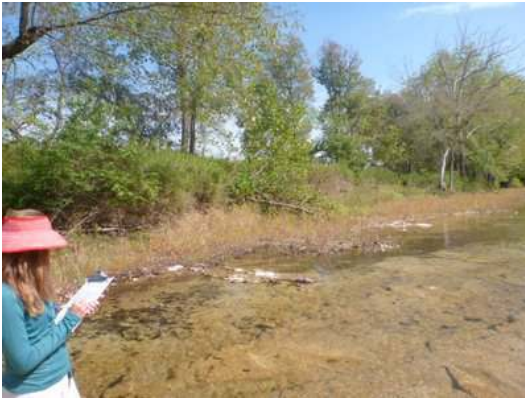
**BCFS1 Inadequate Riparian Corrdior**

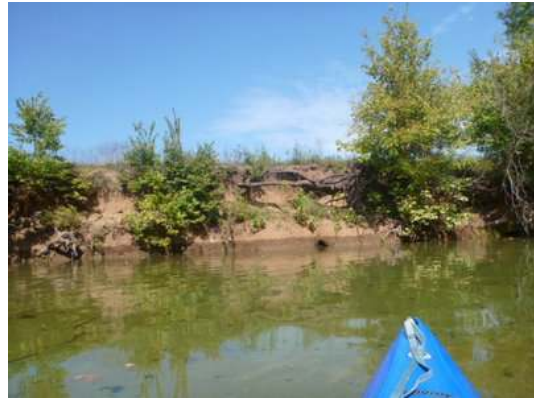
**BCFS2 Inadequate Riparian Corrdior/Bank Erosion**

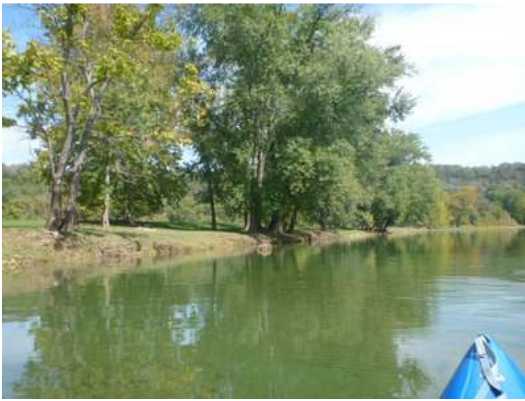
**BCFS3 Inadequate Riparian Corrdior**

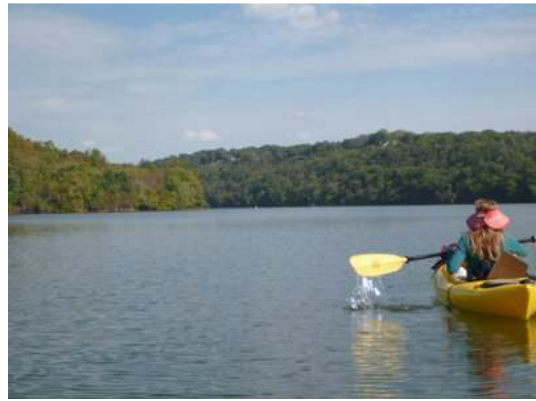
**BCFS4 Bull Creek turns to lake**
