# Bull Creek Watershed

## Visual Assessment Survey

Prepared for:  
Missouri Department of Conservation

Authors:  
Brandy M. Henderson  
and  
Susan A. Sleeth  
Undergraduates  
Missouri State University  
Geology Department

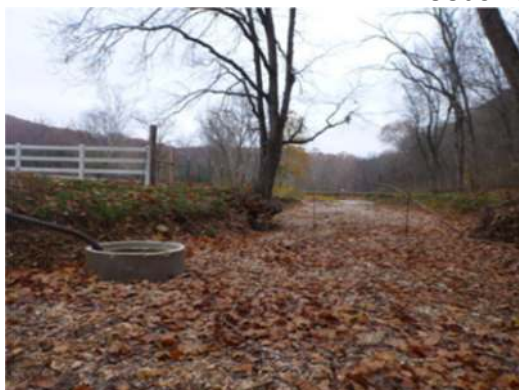
**WFN1 Agricultural Influences**

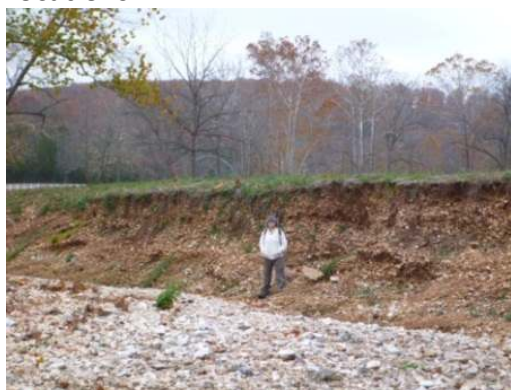
**WFN2 Bank Erosion**

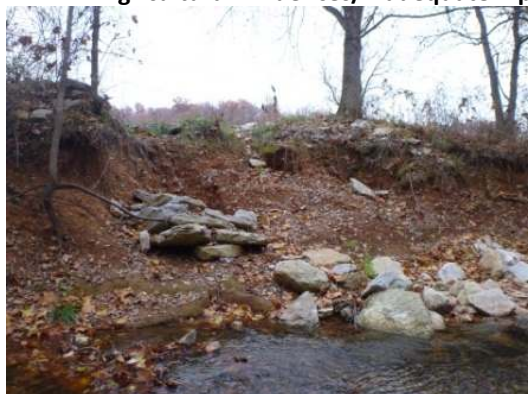
**WFN4 Agricultural Influences**

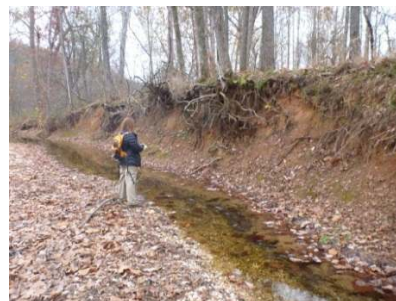
**WFN8**

**Agricultural Influences/Inadequate Riparian Corridor/Bank Erosion**

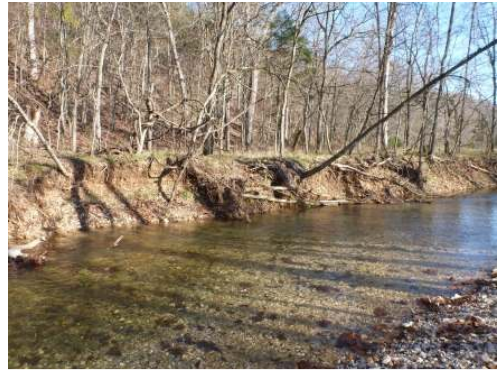
**MWF2 Bank Erosion**

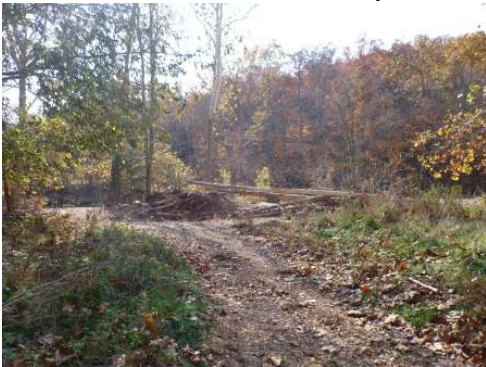
**SWF7 Recreational Trail-Bank Erosion**

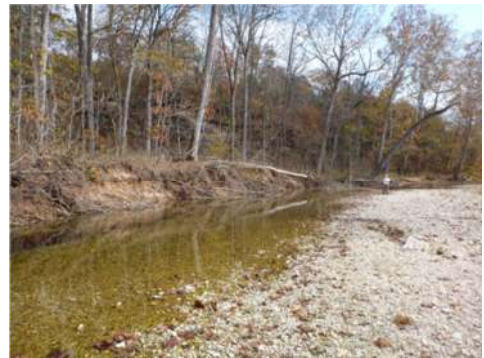
**SWF8 Bank Erosion**

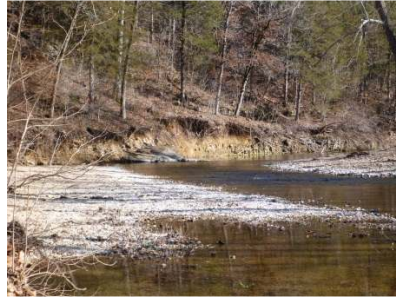
**BCW2 Bank Erosion**

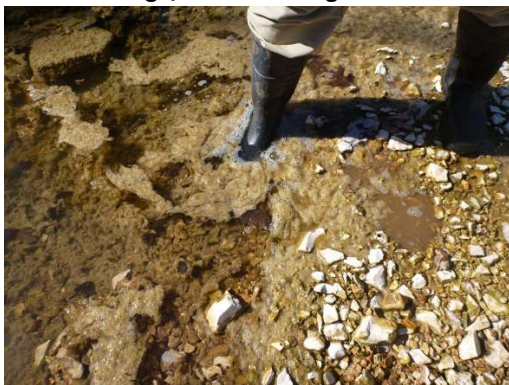
**BCW6 Algae**

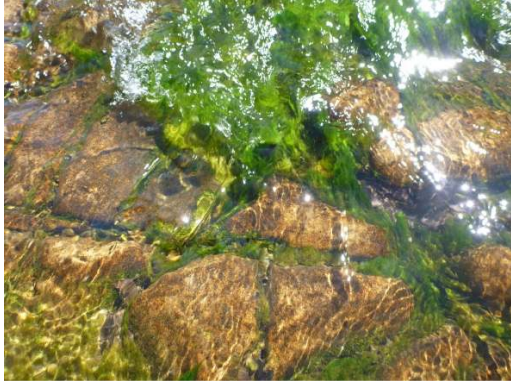
**BCW8 Algae**

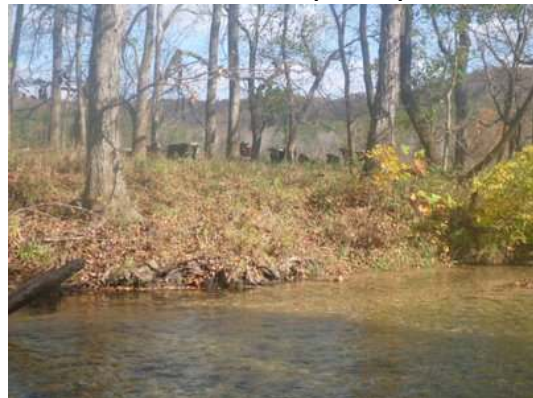
**BCN4 Agricultural Influences-Cattle Stream Access**

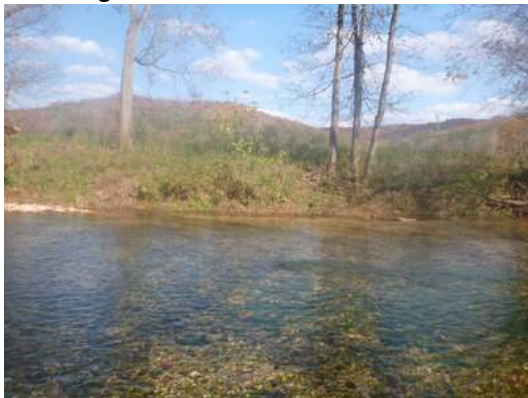
**BCN5 Algae**

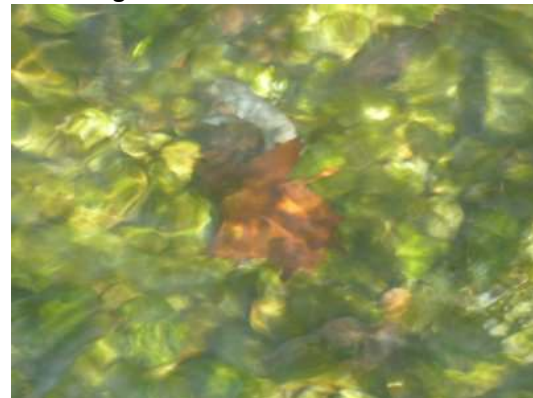
**BCN6 Algae**

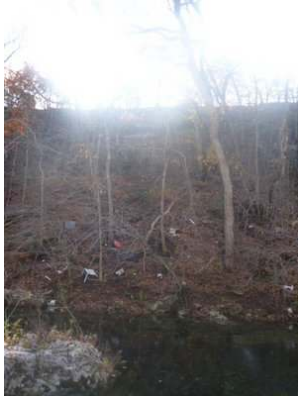
**BCN7 Trash Dump Site**

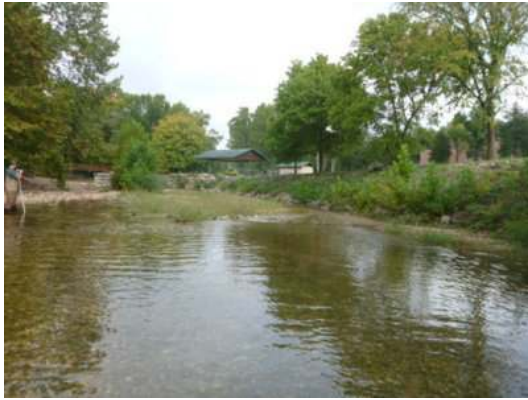
**BCM1 Suburban Influences**

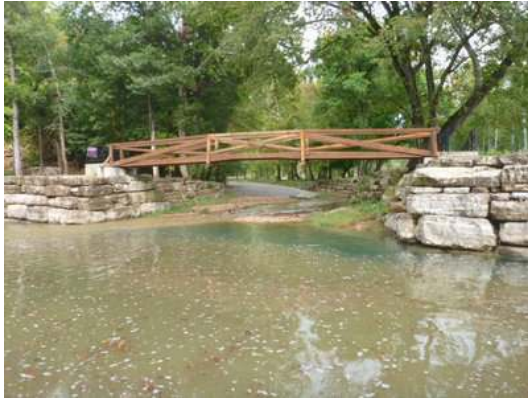
**BCM3 Suburban Influences**

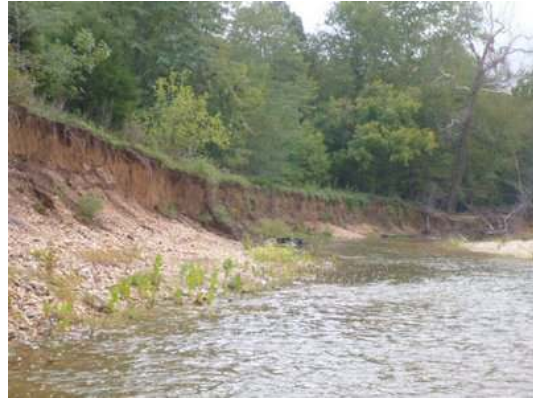
**BCM4 Bank Erosion**

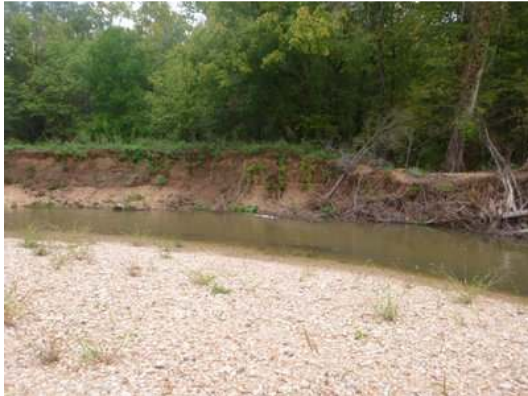
**BCM5 Bank Erosion**

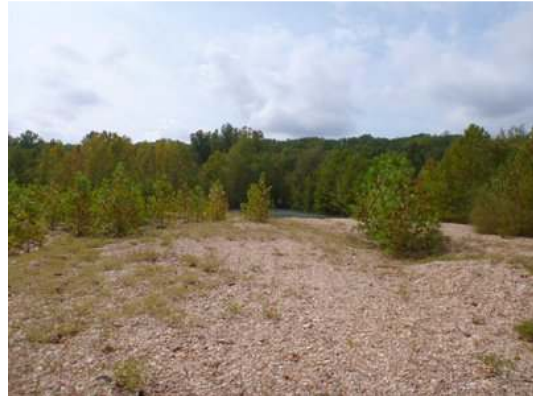
**BCM6 Abandoned Gravel Mine**

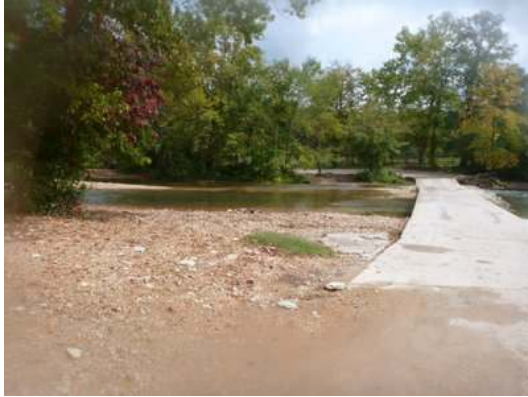
**BCMN7 Road/Brdige Crossing**

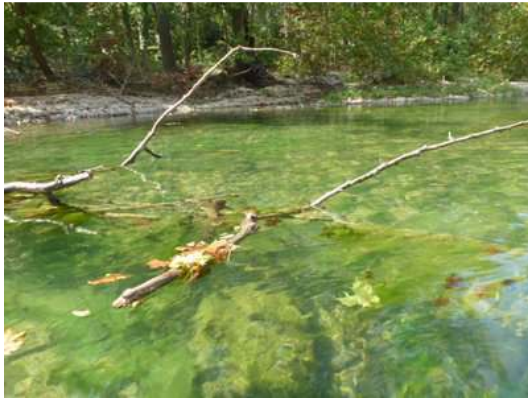
**BCMS1** Algae

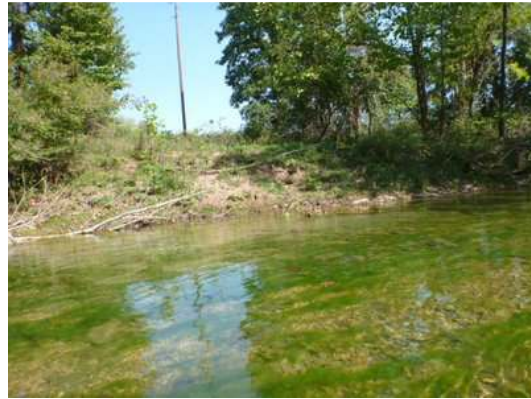
**BCMS2** Algae
